Manhole Inspection Summary

Manhole # S25E__036MH

Insp Date: **8/7/07 11:40 AM**

Location Address: **221 CARROLLTON AVE**

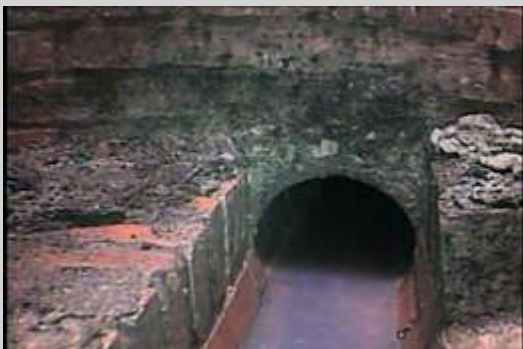
6 O'Clock Inflow

8 in. Circular Gravity Sewer
Pipe In @ 6 O'Clock

Pipe Height: **7.2** (in.) Rod and Bar (Angled)
Pipe Material: **Clay** ☐ Pipe Lined
Invert Depth: **8.87** (ft.) Flow Characteristics: **Slow**
Deposits: ☒ **None** ☐ Mud ☐ Sludge ☐ Debris ☐ Grease
Silt Depth: (in.) Deposits Extent:
Infiltration: **None** Pipe Seal Cond: **Sound**

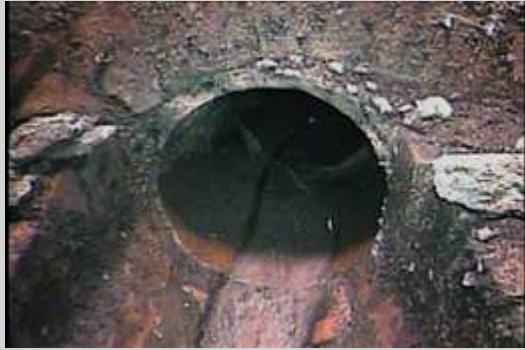
9 O'Clock Inflow

8 in. Circular Gravity Sewer

Pipe In @ 9 O'Clock

Pipe Height: **8.4** (in.) Rod and Bar (Angled)

Infiltration: **None** Pipe Seal Cond: **Sound**
